**MEDIA RELEASE**

## **TEREX KEEPS WASTE MOVING**

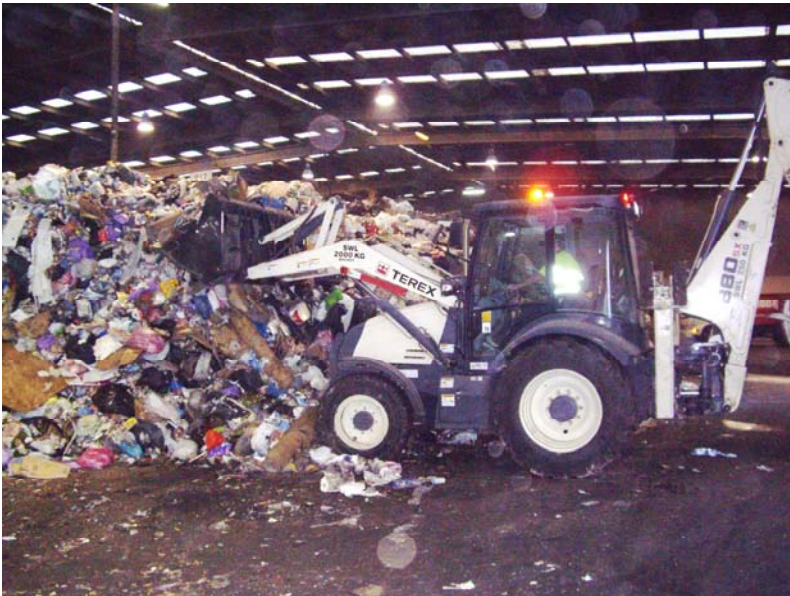
*The modified TEREX 880 at work in WSN's Artarmon recyclingcentre*

Semco responded to WSN's requirements by developing a modified Terex 880 Centremount Loader backhoe. This configuration was selected because of the design's wider stabiliser stance and higher ground clearance that prevents damage from the concrete wall surrounding the pits.

The Terex 880 has a longer hoe for maximum reach and convenience and the simpler design eliminates maintenance-intensive extra hydraulics, locking rams and sliding mechanisms.

Semco's Graham Murphy said some of the key modifications included bolt-on edges on the 4 in 1 bucket, belly guards all round to protect from intrusion of waste to prevent damage to vital components, an engine idle timer to ensure a cool down period between engine shutdowns and a hydraulically actuated grab with specially guarded circuitry to allow more dextrous waste handling and nimble control.
